CIVIL AVIATION ACCIDENT

REPORT NO 04/380

**FINAL REPORT ON THE ACCIDENT TO
NETWORK AVIATION SERVICES LTD.
PARTENAVIA (P68C) AIRCRAFT
REGISTERED 5N - ATE AT
IGBOGBO VILLAGE, IKORODU
LAGOS STATE
ON SATURDAY 16TH JUNE 2001**

**Report on the Accident to Network Aviation Services Limited
Partenavia (P68C) Aircraft Registered 5N-ATE at Igbogbo Village,
Ikorodu, Lagos State On Saturday 16th June 2001.**

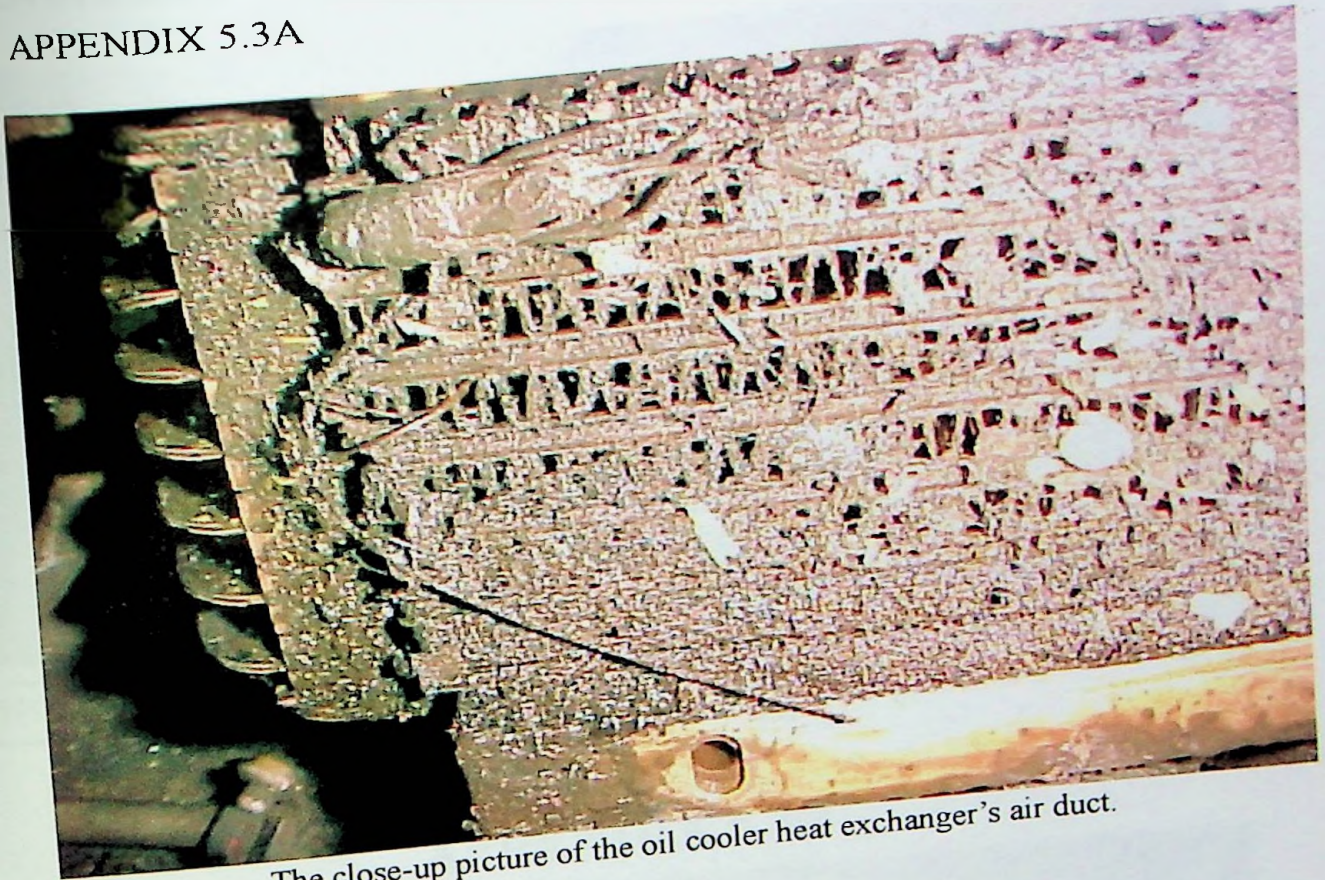
APPENDIX 5.3A

It looked like the heat exchanger had never been removed for cleaning since the original installation at the factory, yet Network Aviation logged that the oil cooler was replaced on the 10th February 2000. The most disturbing discovery was the claim in the aircraft logbook that the oil cooler was newly replaced only 54

The close-up picture of the oil cooler heat exchanger's air duct.

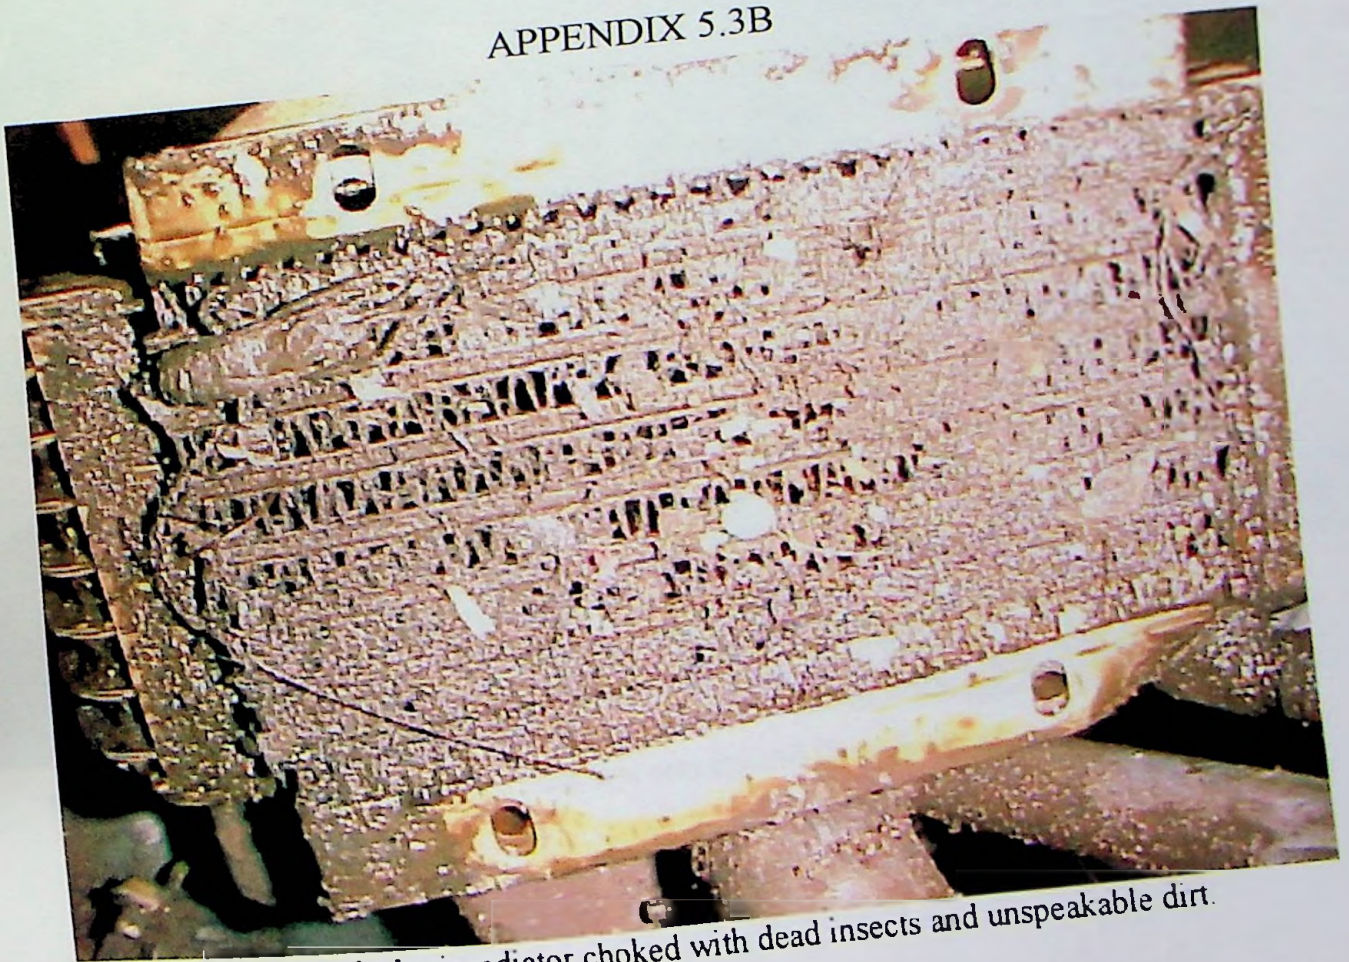
APPENDIX 5.3B

- (a) Near total blockage of the oil cooler's air inlet to the heat exchanger of the cooler. This would inhibit effective cooling of the engine oil. (See appendices 5.3A and 5.3B)
- (b) Cooling and lubricating engine oil system hose had ruptured since an unspecified time before the accident and the two halves were passed through a canvass conduit instead of replacing the entire hose with a new one.
- (c) There were traces of engine oil spray on all the engine-driven accessories and other components. It is probable that the quantity of the engine oil could have diminished to below effective cooling level.

The oil cooler's air radiator choked with dead insects and unspeakable dirt.

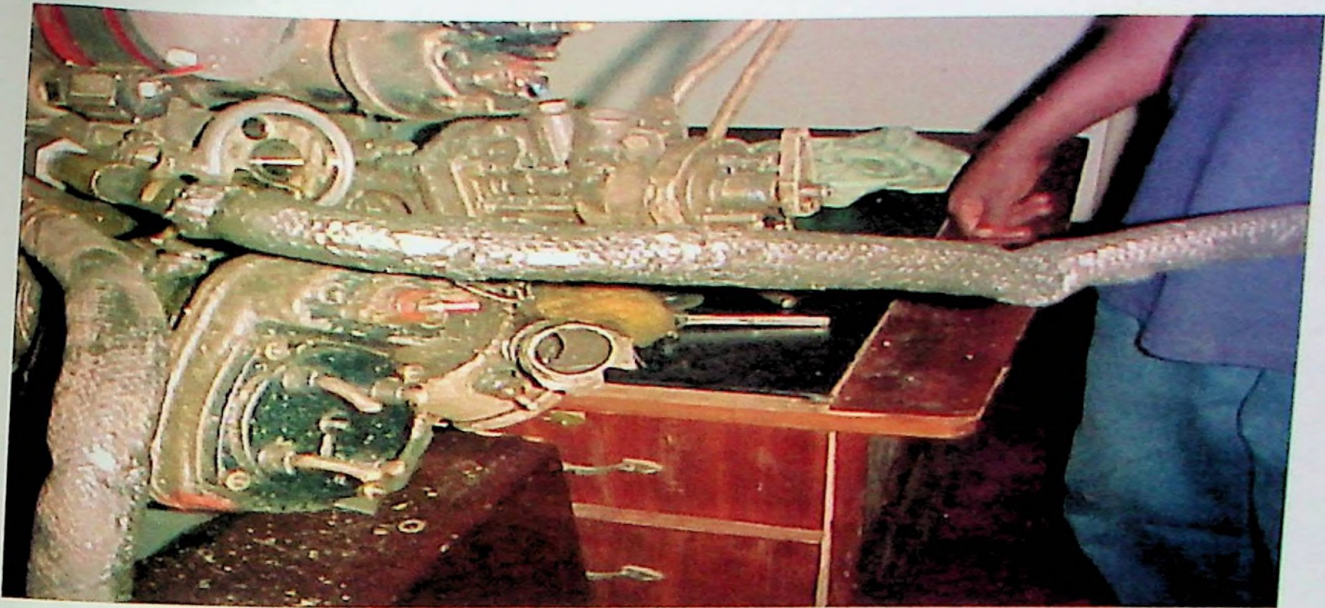
The engine oil pressure line from the oil cooler, which was carrying lubricating oil into the engine accessory gearbox had fibrous rupture and had snapped in two, due to depreciation from high oil temperature or mishandling by personnel. The two severed rough ends were then passed through the hose's canvass conduit. Engine oil passage could be badly restricted, engendering poor and ineffective cooling, lubrication and proper circulation. The engine oil was badly seeping through the woven canvass. (Please see appendix 5.4A and 5.4B) and evidence of such seepage was manifested around accessory gearbox area, that some accessories like magnetos, engine driven fuel pump, engine driven propeller governor and vacuum pump were sprayed with engine oil, which made everywhere looked messy and soggy with oil.

APPDX 5.4A Picture of the canvass conduit, housing the accessory gearbox's broken high pressure hose

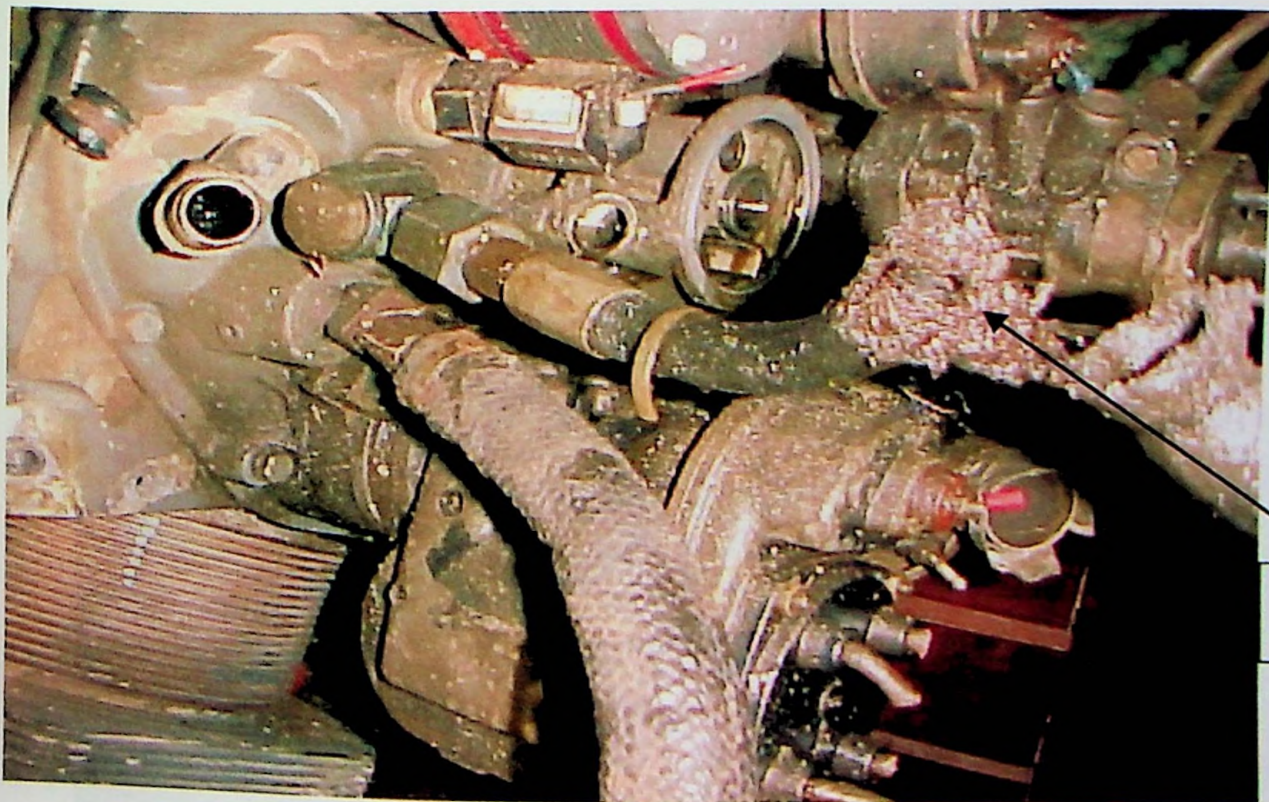
APPENDIX 5.4B

High Pressure
Hose's end:

Pix showing the oil's high pressure hose that was spliced through the canvass conduit.

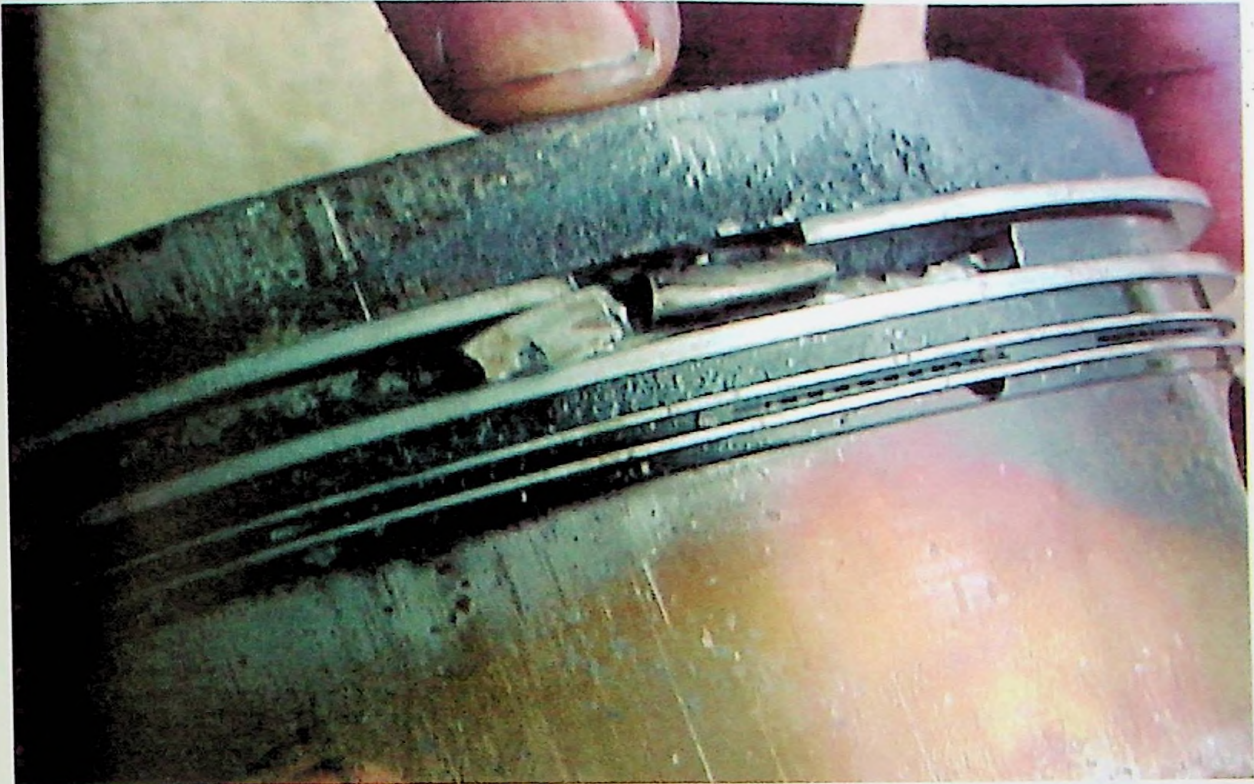
However, opening up the engine in the laboratory showed that the supposedly replaced 'new' piston was the problem again. It was discovered that the top compression ring-land of the piston had chipped off owing to corrosion pitting. About 43 millimetres section of the top compression ring-land's circumference had broken loose and the fragments were only held in place by the cylinder wall. (See appendix 5.5A and B). No wonder some metallic flakes were found in the engine oil filter paper element, when it was cut open by the AIPB for any indication of pre-impact engine break-up problem. Evidently, the maintenance engineers, who had previously worked on the cylinder, had forcefully removed the 'sticky rings' and had, in the process, damaged the compression ring-land. Our impression here is that the same piston and compression rings were returned into the cylinder and the engine re-assembled and put back to service. Entering the job in the engine logbook as 'replaced with new piston and rings' is misleading and the AIPB will hold on to the belief that these cylinder parts were not actually replaced with new ones, until the Network Aviation services presents the tags removed from the 'new' piston package. When the engineer was contacted to tender this tag, he responded that the tags would be brought to AIB's office at Ikeja and this has not been done till date.

The analysis of the broken compression ring-land is that when the piston is on the 'compression stroke', a lot of the **air/fuel charge** in the cylinder will escape into nowhere else, but the crankcase. The cylinder will not deliver full power or it will develop just about 25% of its power as the above compression check had indicated. Evidence of this could be seen on the piston head and the cylinder wall, where carbon deposits were pronounced. The exhaust blow-by was, also, evident inside the cylinder wall and traces of this were found in the engine's crankcase, showing that both the exhaust and the charged air found their ways into the crankcase on each stroke of the piston. The indication of this finding is that, the exhaust fume in the crankcase would generate high temperature of the operating engine, most especially in the cylinder No.3, which would be to the detriment of the engine's output performance.

The number 3 piston showing the damaged top compression ring-land.

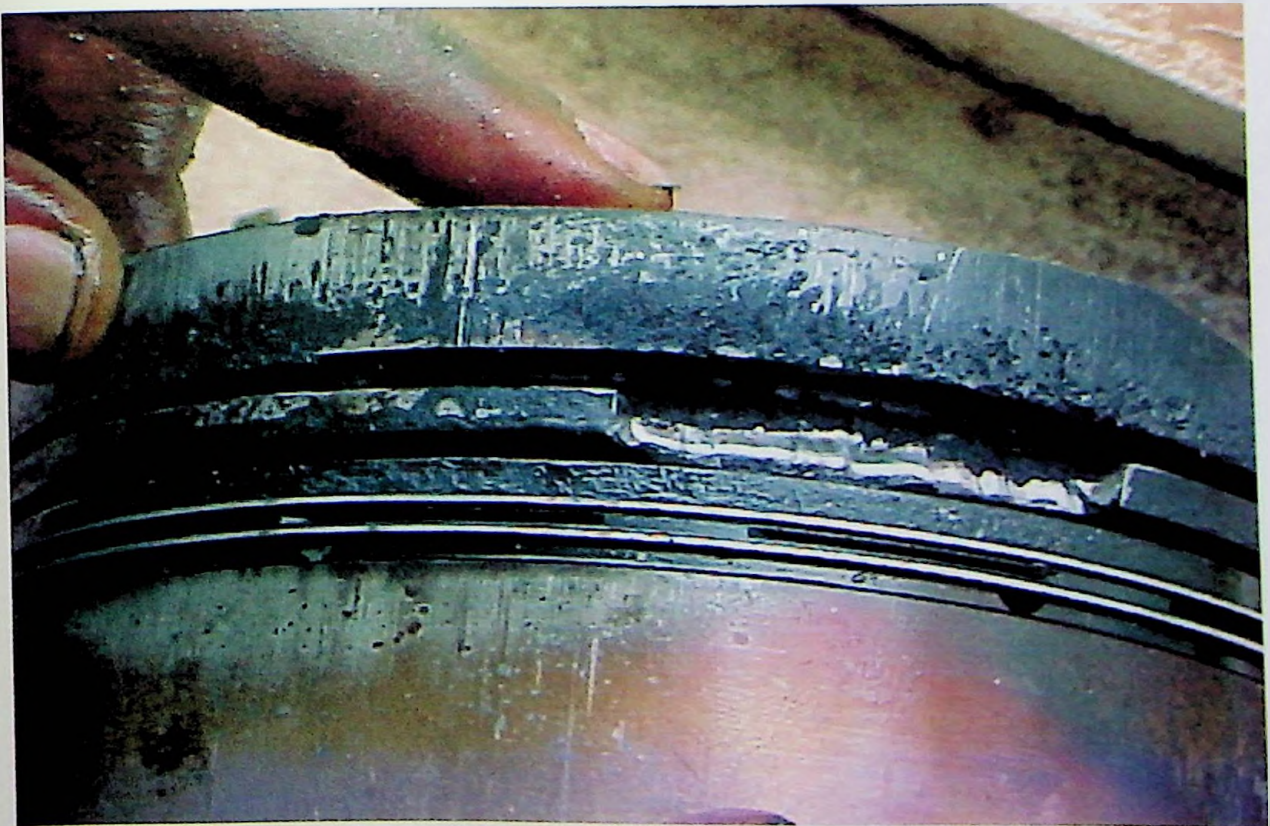
APPENDIX 5.5B

The close-up picture of the top compression ring-land and the carbon deposit.

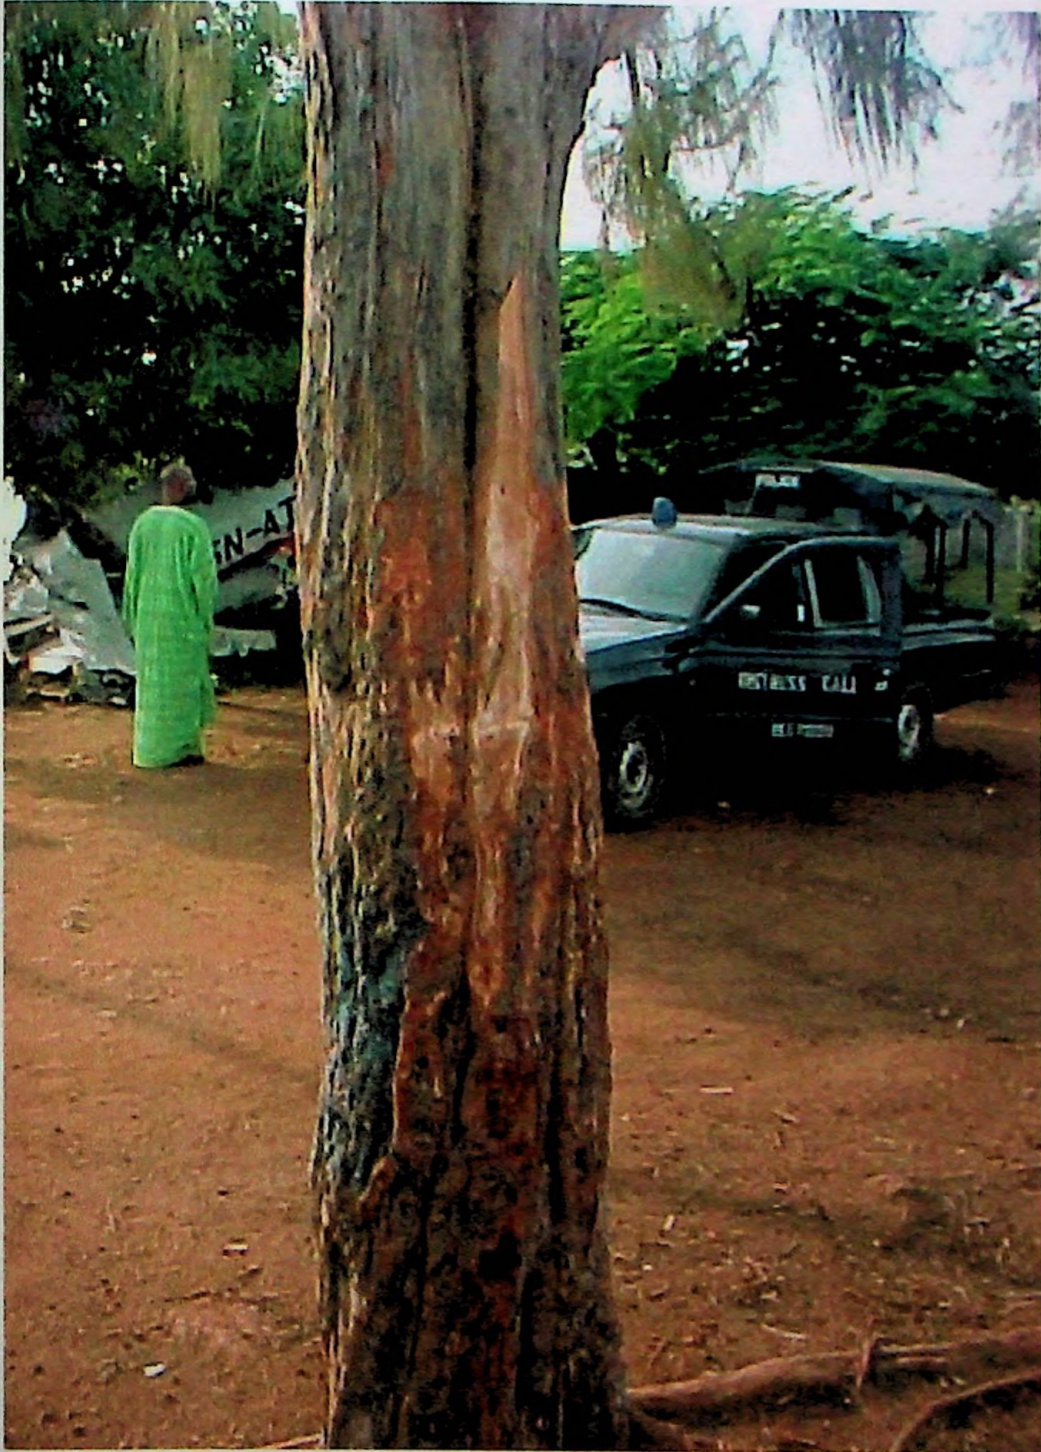
The first impact after touch down was the left wing colliding with the first fir-tree at the beginning of the football field. The collision with the tree now changed the direction of the landing roll towards the school's perimeter fence along which there are other fir-trees that adorn the other side of the leading access road in the School's compound. The second and fatal impact was with the concrete wall fence and some adorning trees. This impact spelt the doom of the unfortunate aircraft and the pilot. The wreckage was intact in one piece only that the two wings, the radome

Picture showing the impact mark on the fir tree

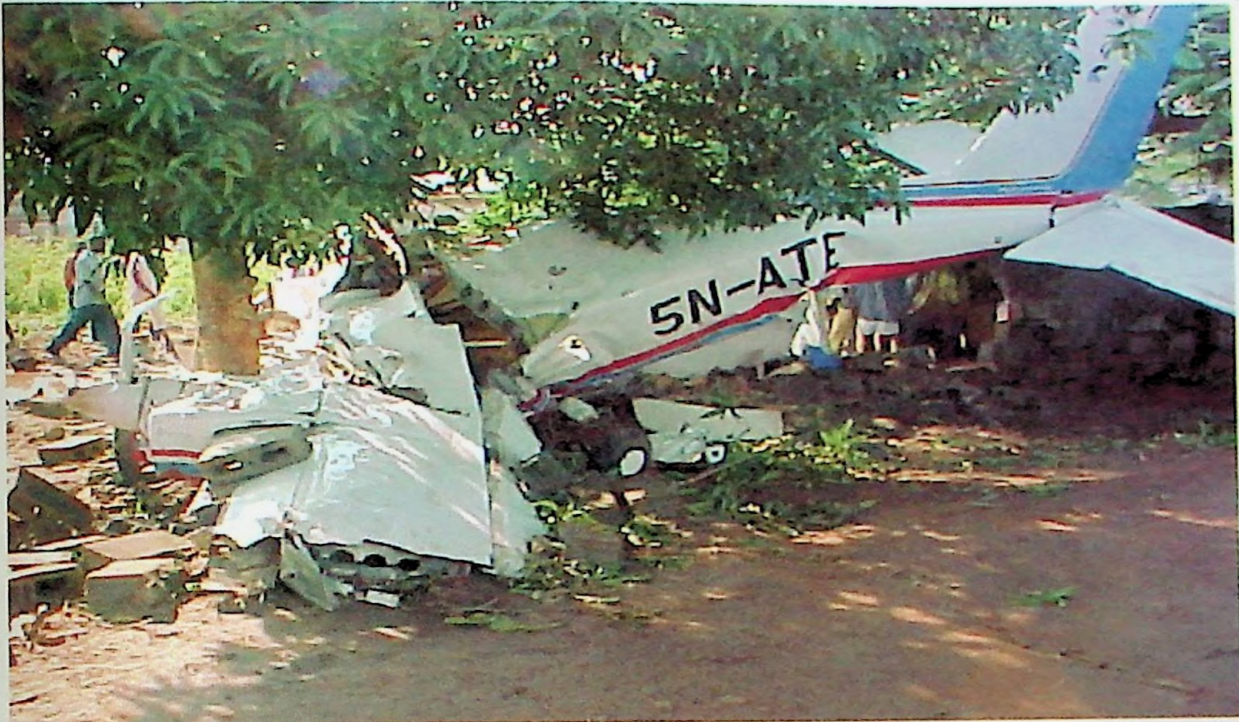
Picture showing the aircraft's wreckage at the crash site

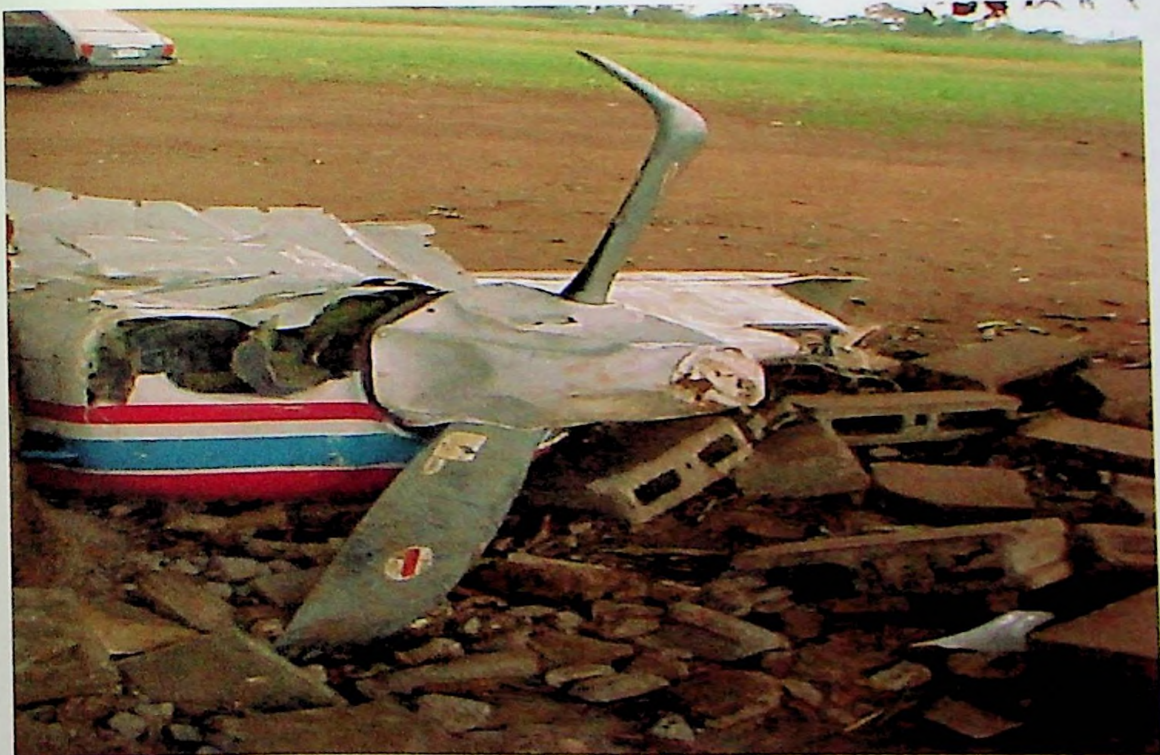
APPENDIX 5.7B

5N-ATE's wreckage showing the Zumusat Isillamiyah football field in the back-ground
