# **CIVIL AVIATION ACCIDENT**

REPORT NO CIA 156

REPORT ON THE ACCIDENT TO THE  
CONCORD AIRLINES FAIRCHILD FH 227B AIRCRAFT  
REGISTERED 5N-ATL AT MURTALA MOHAMMED  
AIRPORT RUNWAY 19L, IKEJA .

ON THE 18<sup>TH</sup> APRIL 1990

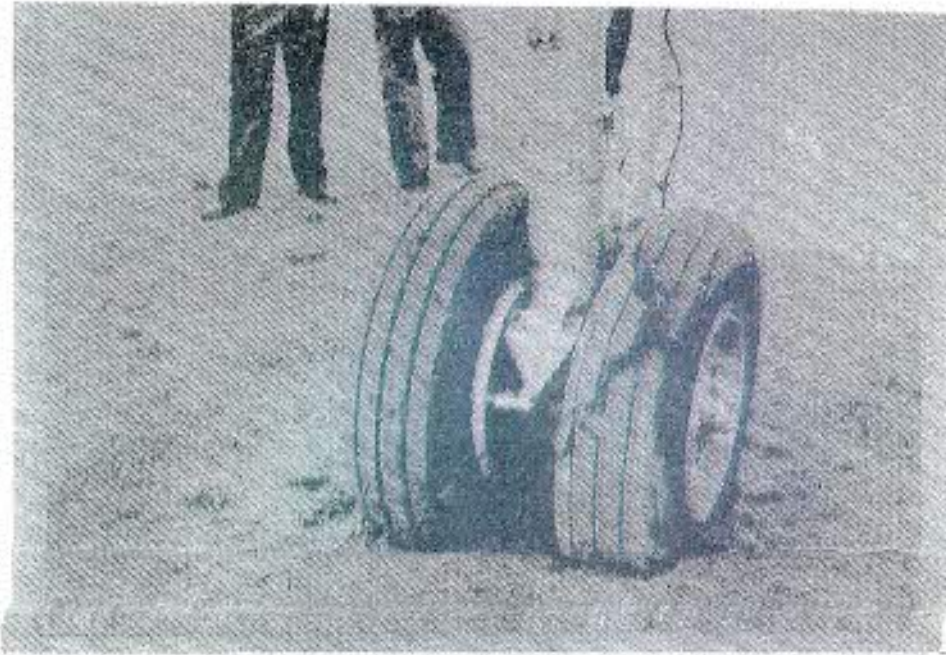
A

The runway edge light assemblies have been knocked off their posts; the electrical transformers which power these lights have been excavated from their buried positions and their open pits or holes have become deadly traps to any aircraft running onto the shoulder. (Please see appendices 1B, 2A & 2B). One of such holes ripped open the No. 2 tire on ATL.

Picture showing number 2 tire was ripped out by the opened electrical transformer pit on the shoulder.

This Bureau believes that if the runway shoulder had been maintained in accordance with ICAO Doc. 9157-AN/901 Part 1, 5N-ATL will still be safe and intact on the runway shoulder at the final stopping point. It could have been taxied or at worst, towed back to the operator's hangar.

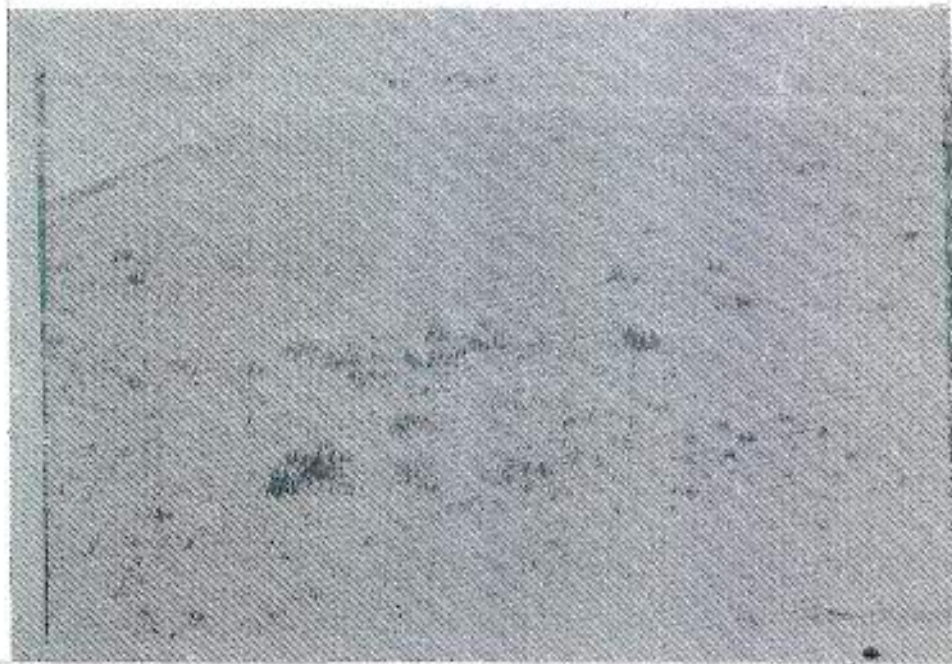
B

Picture showing the uncovered runway edge lights electrical transformer pit which through the tire.

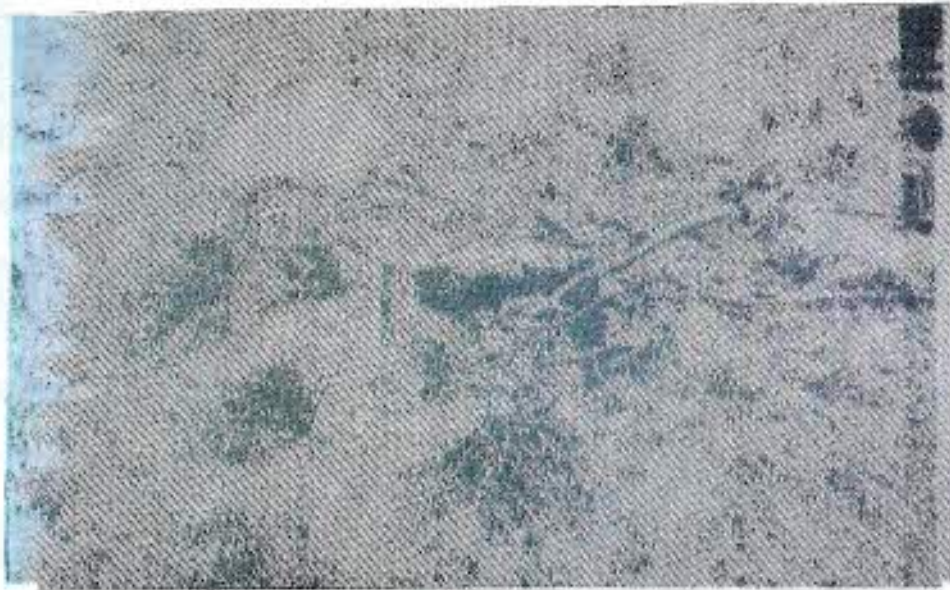
A

Another uncovered electrical transformer pit which dotted the length of the runway shoulder.

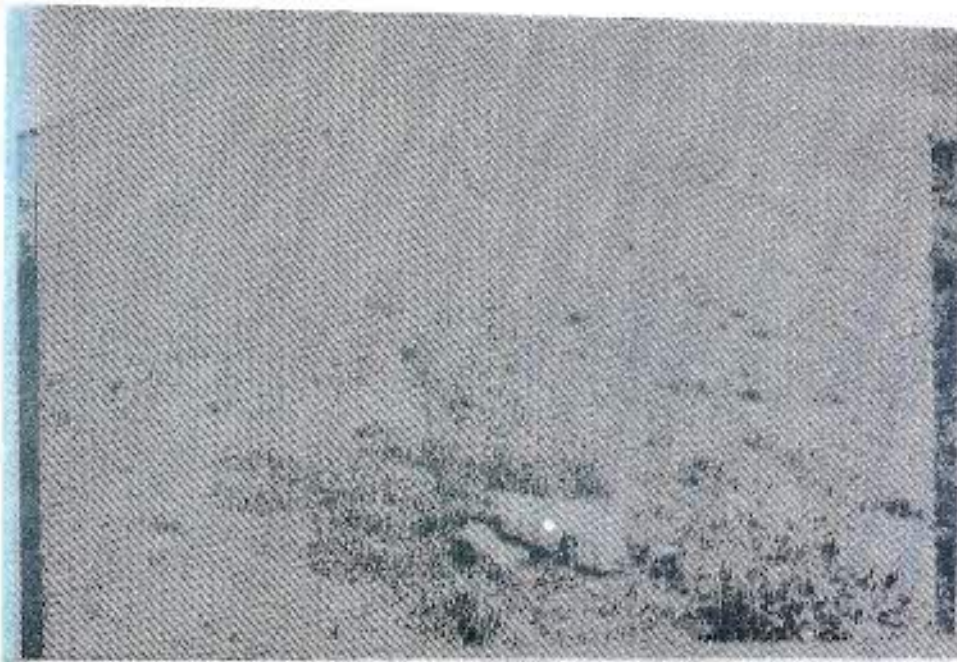
B

Another poorly maintained transformer pit.

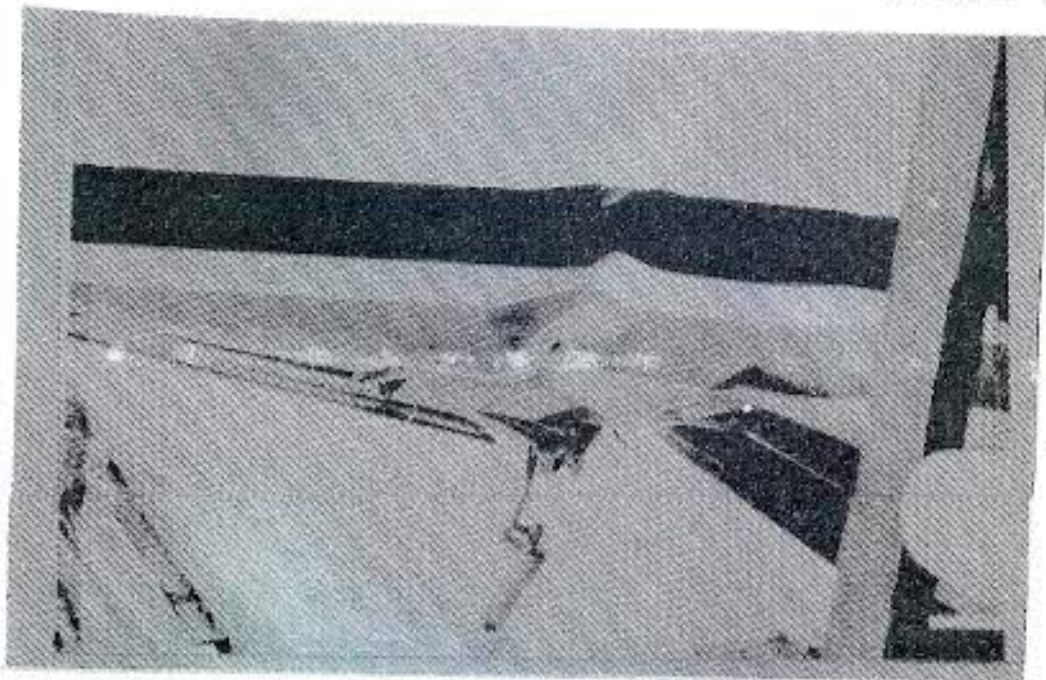
A

and fractured the upper torque-link which collapsed the nose gear to retraction. The sudden nose-gear retraction made the fuselage forward section to impact with ground with a devastating force which distorted the airframe. (Appendix 3).

The damage to the underside nose section of SN-ATL.

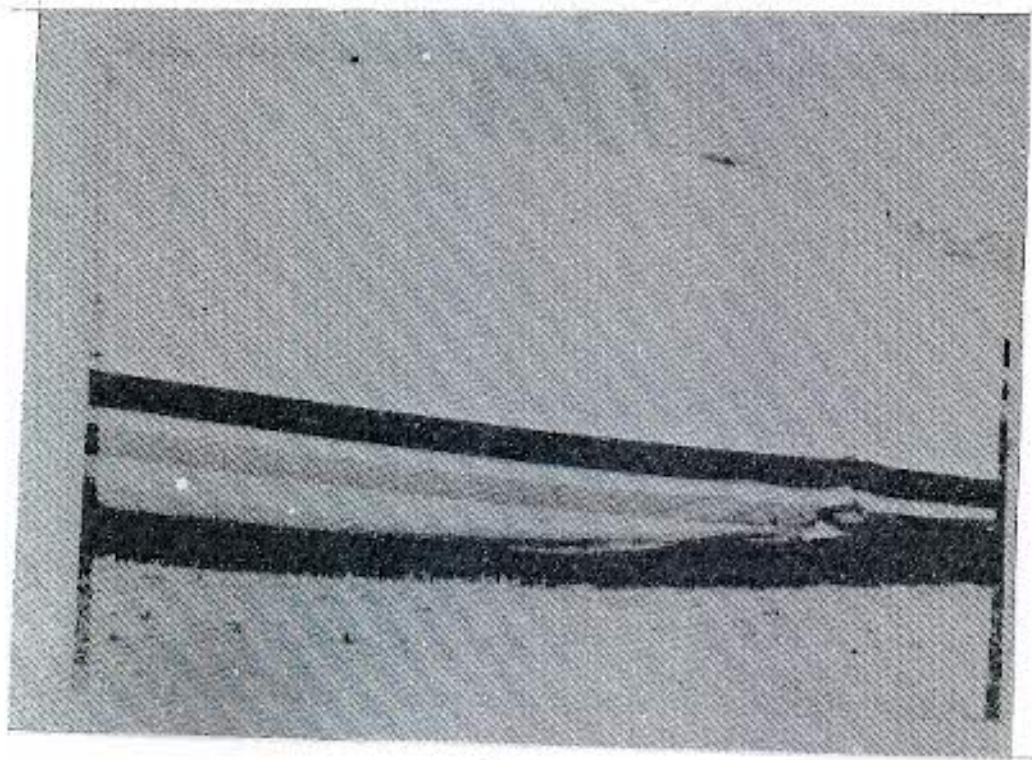
B

The nose section on the ground after the impact.

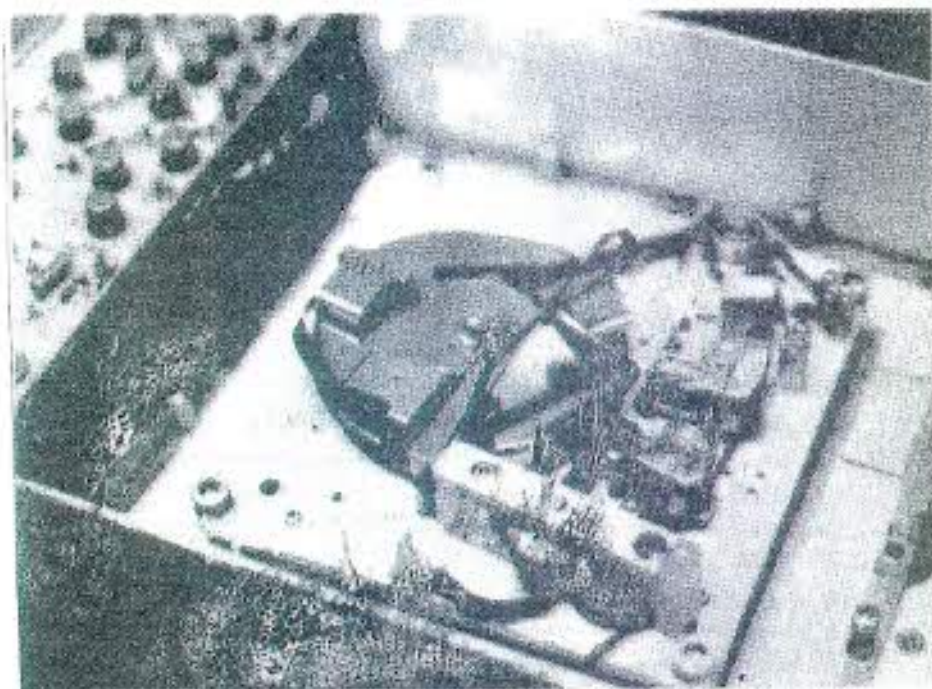
The CVR too was in a very good condition externally when it was recovered but when opened up, it was found that one of the allen screws bolting the two halves of the crash protection together was loose. This would only have caused a problem if there had been fire.

When the crash protection was removed, it was immediately evident that the tape was jammed and that some tape had become unspooled within the case (see appendix No.7).

FIG. 10 CVR AFTER REMOVAL OF CRASH PROTECTION.

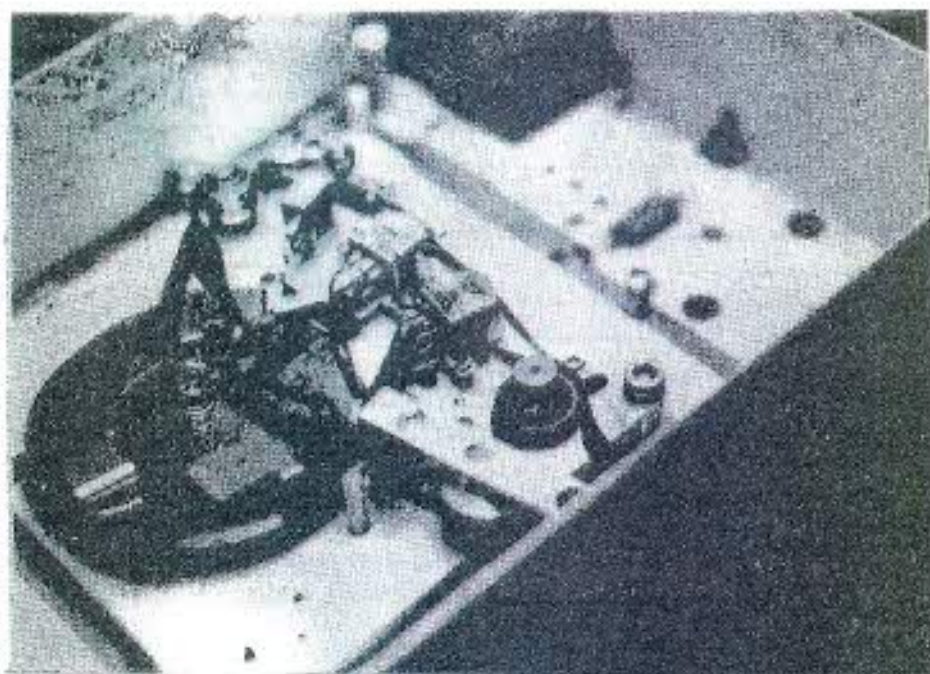
B

The tape, an endless loop of 30 minutes duration, was taken from the centre and collected on the outside of the tape spool. The tape having passed the recording heads had become tightly wound around the tape capstan and the recording head. This tape situation had actually jammed the machine from recording the conversation on this unfortunate flight.

FIG. 11 TUBE WOUND ROUND TAPE GUIDE.
