**Federal Public Service  
Mobility and Transport**  
*Belgian Civil Aviation Authority*

***Air Accident Investigation Unit***

**FINAL REPORT ON THE ACCIDENT OCCURRED  
ON 21/7/2007  
AT CHARLEROI ON A PIPER SENECA II  
REGISTERED OO-MLF**

**Ref. AAIU-2007-13**  
**Issue date: 25 March 2008**  
Status: Final

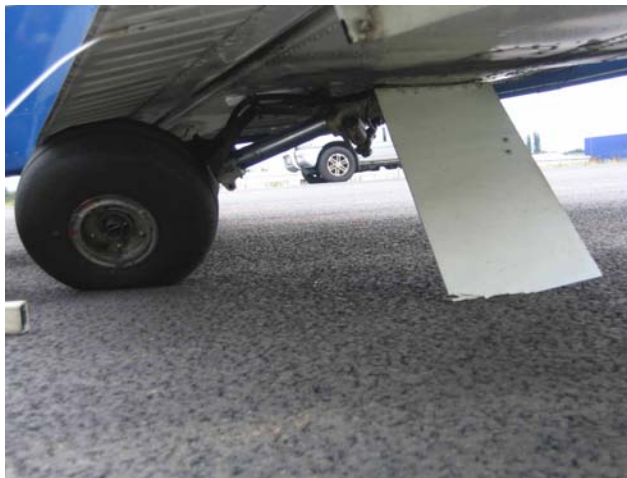
Right Wing.

The lower side of the wing is damaged, including the flap.

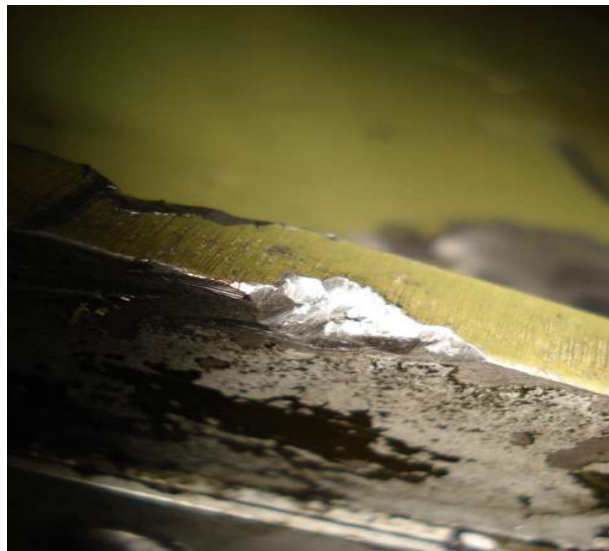
The lower side of the main spar shows several serious dents.

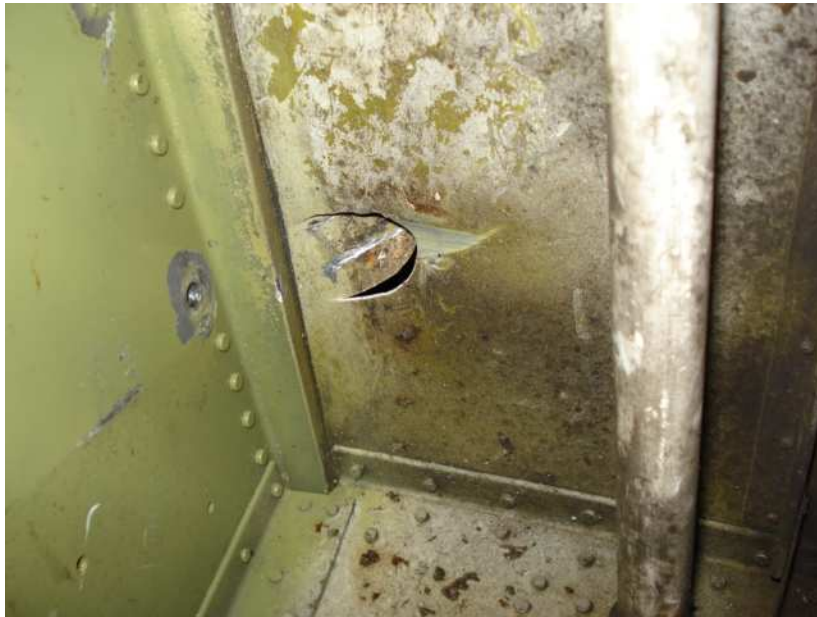
There is a hole in the RH Wing upper surface.

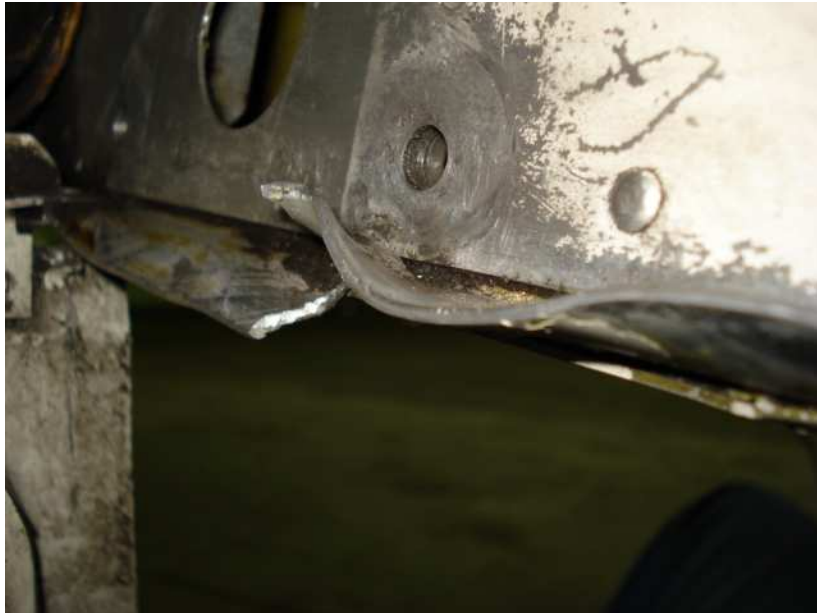
There are also internal damage on the lower side of the secondary wing spar:

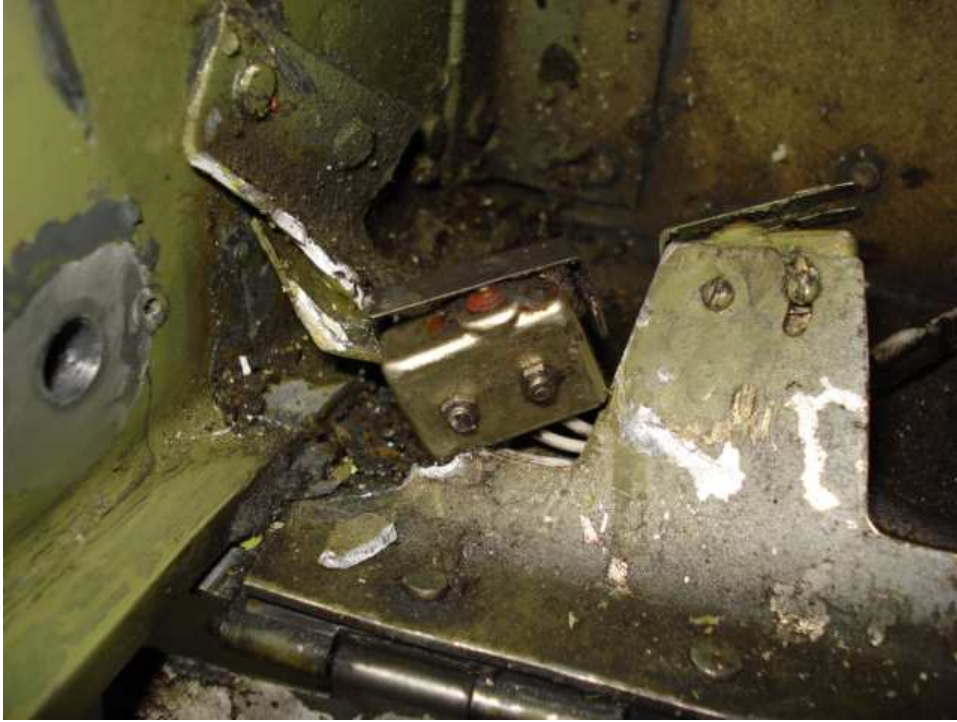
and on the MLG door hinge support web:

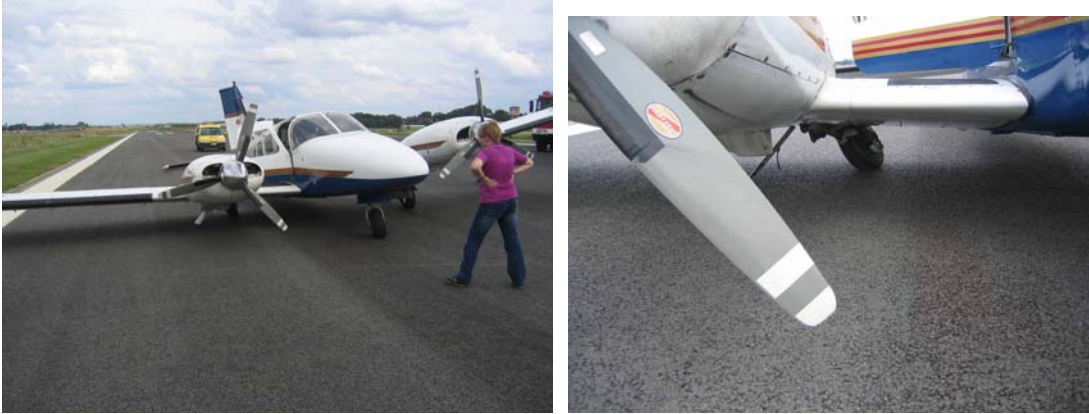
The aircraft came to a stop at 795m from the runway 25 end, and 5m from the lateral side.

The RH tyre left a trace on the runway, starting 204m from the end position of the aircraft, while the LH tyre left a trace, starting 94m from the end position of the aircraft.

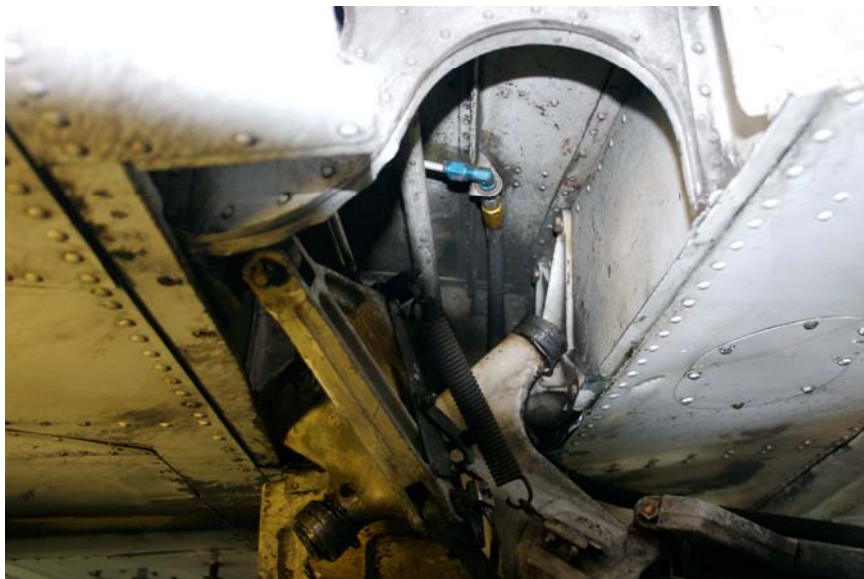
Both Support Fittings were found sheared.

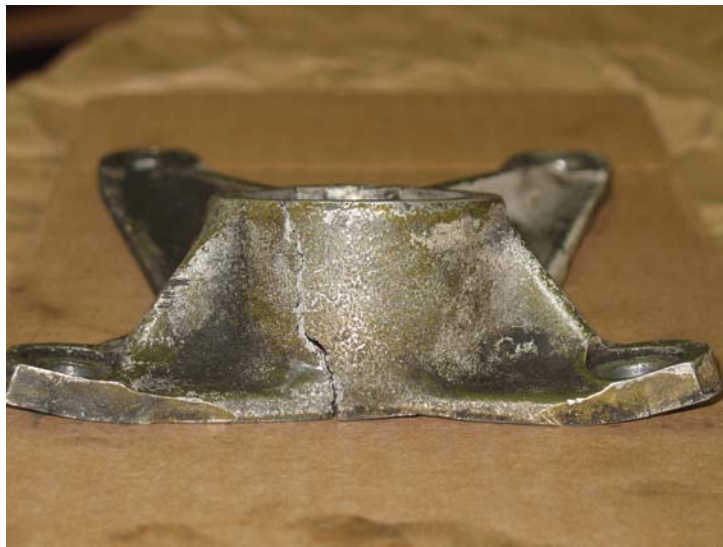
Aft Fitting, view from below

The Aft Support Fitting is severed in 3 pieces. All 3 pieces were still attached to the rear spar by the mounting bolts.

The Support fitting itself is deformed in a conical shape.

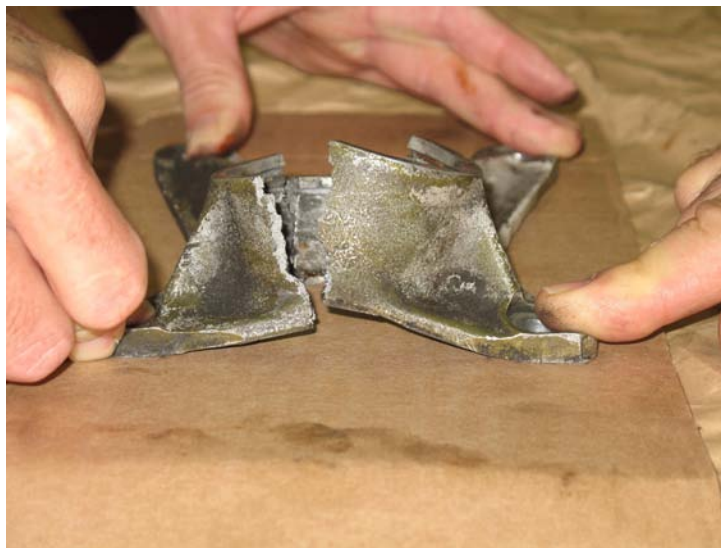
Aft Fitting, showing deformations.

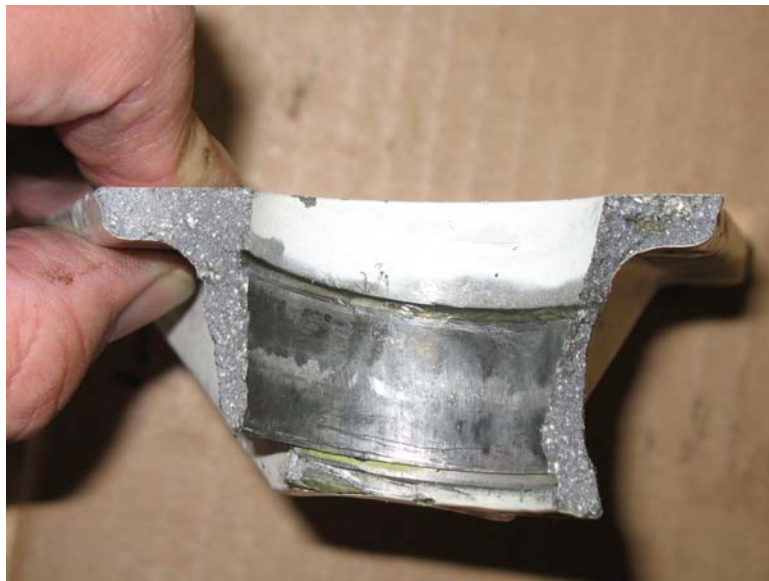
The Forward Support fitting is severed in 3 pieces; the 2 main parts were recovered, as they were still attached to the wing front spar.

However, a third piece is missing on the Forward support fitting. This small piece is located on the outboard side of the fitting, indicating a possible lateral force.

The colour of the fracture is different from the fracture of the aft support fitting.

Front fitting, fracture.

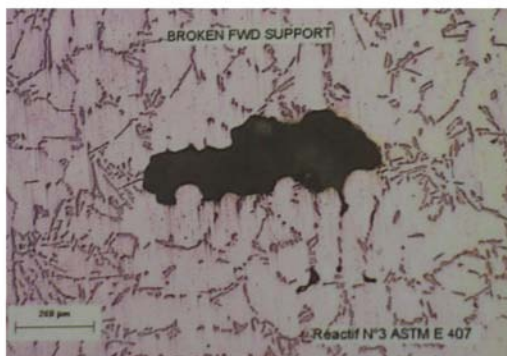
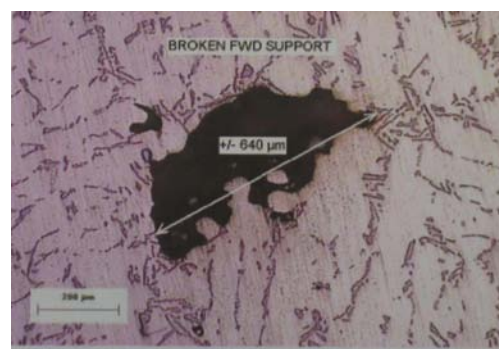
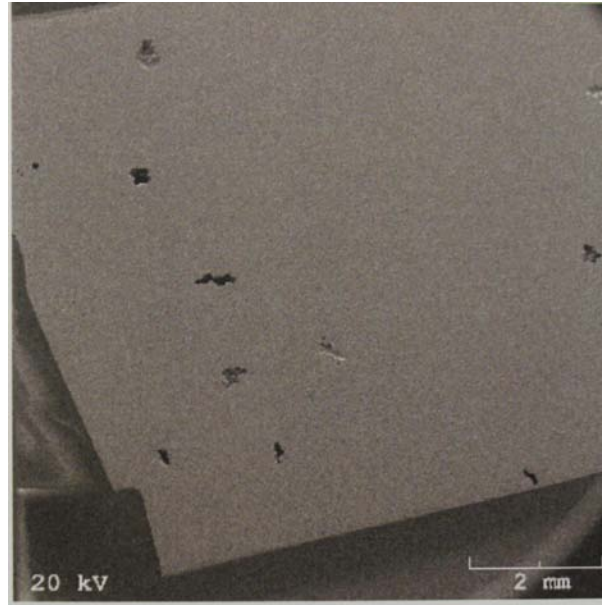
In particular, the Forward Support Fitting show a content in Silicium of 14%, while an A356 alloy has a typical Silicium content of 6,5 to 7,5 %. The Silicium was found present under euhedral form (linear and fragile), instead of the fiber form.

The metal structure of the fitting showed also an abnormal presence of porosities, and linear precipitate.

The porosities could be seen with the naked eye.

The fitting failed under a totally fragile (static) fracture mode.

To further determine the cause of the departure from manufacturing specifications of the Forward Support Fitting, and take appropriate action to ensure continuing conformity.
