# **CIVIL AVIATION ACCIDENT**

REPORT NO CIA 156

REPORT ON THE ACCIDENT TO THE  
CONCORD AIRLINES FAIRCHILD FH 227B AIRCRAFT  
REGISTERED 5N-ATL AT MURTALA MOHAMMED  
AIRPORT RUNWAY 19L, IKEJA .

ON THE 18<sup>TH</sup> APRIL 1990

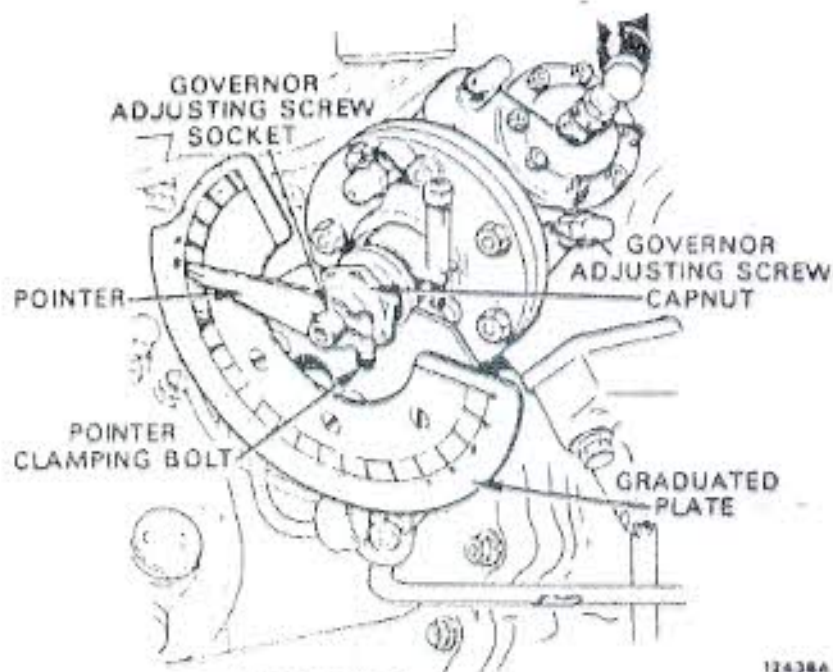
Fuel pump governor setting jig  
 Fig. 202

When the engine was installed on the test cell and ran as received, the test cell crew and this Accident Inspector observed that the overspeed governor started to govern the engine speed at a low setting of 14,974 rpm, instead of the maximum rpm of 15,000. The engine was then shut down and necessary re-adjustment was performed using the setting jig on the governor; the second run indicated that the governor, started to control the engine speed at 15,000 rpm. At this desired speed, the power output was 1,836 shaft Horse Power (SHP) and the Turbine Gas Temperature (TGT) was 802 degrees Celsius, which was not acceptable to maintenance standard. The maintenance manual calls for 790 degrees Celsius TGT at this speed and power output.

- (6) When the governor is set to control at 14,700 r.p.m., plus 0, minus 100 r.p.m. close the throttle and stop the engine. Reposition the pointer to coincide with the 0 degree mark.
- (7) Loosen the capnut and carefully move the pointer in a clockwise direction to the 180 degree mark. This adjustment will set the governor to control the actual governed speed. No attempt must be made to check this setting. Tighten the capnut and lock it with 0.028 in stainless steel wire. Ensure that the pointer setting is not displaced, then remove the setting jig.
- (8) Reset the automatic feathering circuit breaker and restore the electrical supply to the automatic feathering circuit.
- (9) Carry out an engine serviceability ground run.
