**Federal Public Service  
Mobility and Transport**  
*Belgian Civil Aviation Authority*

***Air Accident Investigation Unit***

**FINAL REPORT ON THE ACCIDENT OCCURRED  
ON 21/7/2007  
AT CHARLEROI ON A PIPER SENECA II  
REGISTERED OO-MLF**

**Ref. AAIU-2007-13**  
**Issue date: 25 March 2008**  
Status: Final

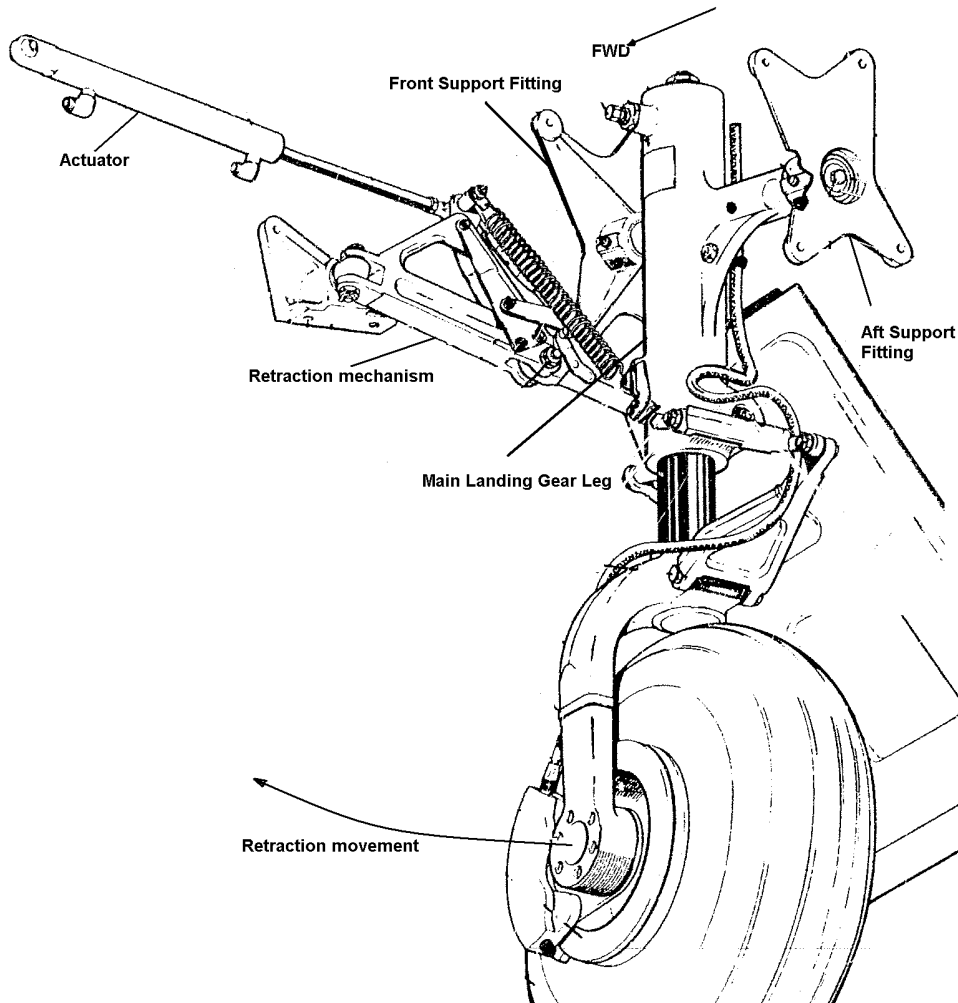
RH Main Landing gear.

Both Support Fittings were found sheared.

The snap-rings, used to hold the bearing in place were not found.

However, a third piece is missing on the Forward support fitting. This small piece is located on the outboard side of the fitting, indicating a possible lateral force.
